AESTHETIC RECOVERY OF THE SMILE USING A SIMPLE AND EFFECTIVE APPLICATION OF PREPOLYMERIZED COMPOSITE VENEERS

CASE REPORT

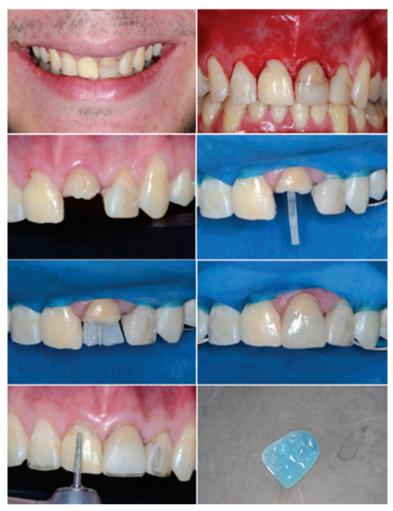
The clinical examination showed a deficient restoration of element 21, with overcontouring, disharmonious color, and caries infiltration; small cervical fracture in element 11, restored with excess composite resin; element 22 with inclination of the distal surface toward the palatal region; absence of proportion between the cervicoincisal size of upper central and lateral incisors and inadequate gingival contour; and presence of bacterial plaque and dental calculus, especially in the lingual aspect of lower incisors (Figure 1A).

Figure 1: (A) Initial photograph; (B) Periodontal surgery of gingival recontouring of elements 12 to 22; (C) Removal of the deficient restoration of element 21; (D) Cementation of prefabricated 0.5 White Post fiberglass post (FGM, Brazil); (E) Performance of adhesive system and application of a thin layer of Opallis translucent composite resin (FGM, Brazil) per palatal region; (F) Final restoration with Opallis A3 and D3 composite resin (FGM, Brazil) by the stratification method; (G) Preparation of elements 11, 12, 21, and 22 with light bevel on the buccal aspect with a 4138 bur (Microdont, Brazil); and (H) Preparation of veneers with 37% phosphoric acid etching.

Initially, instructions were provided on oral hygiene and adequacy of the oral environment, which included supragingival scaling with periodontal curettes (Hu-Friedy Mfg.Co, LLC3232 N. Rockwell St.Chicago) and prophylaxis with Robinson brush (Microdont Micro Usinagem de Precisão Ltda, SP, Brazil) and prophylactic paste (Herjos 90G Tutti Frutti – RJ- Brazil). Next, gingivectomy was performed from element 12 to element 22 to improve the gingival contour, considering that central incisors presented small cervico-incisal size relative to lateral incisors and canines. The surgical technique selected was external bevel gingivectomy (16,17), with the purpose of recontouring the lining tissues. The periodontal pocket depth was assessed with a millimeter bur (Hu-Friedy Produtos para Saúde Ltda - Rio de Janeiro - RJ - Brazil) followed by an external bevel and intrasulcular incision with a scalpel blade (Maxicor - Paraná - Brazil). The incised area was removed with a Gracey periodontal curette (Golgran 2013 Desenvolvimento N2 Mídia - SP - Brazil) and the tooth surface exposed was subjected to scaling and flattening (Figure 1B). There was no suture or placement of surgical cement, therefore allowing a second-intention healing.

After two weeks, the composite resin restoration of element 21 was removed, considering the presence of overcontouring and caries infiltration. After removing the caries and the restoration, little remaining tooth structure was verified (Figure 1C). The post was made of fiberglass composite and epoxy resin, featuring high mechanical strength, double taper, radiopacity and aesthetics. In anterior teeth, the indication is determined for 50% loss of structure coronary. For stabilization of the coronary reconstruction, the post occupied two thirds of the length of the dental remnant. Proper endodontic treatment allowed the absolute isolation of the element, preparation of the conduit by removing the gutta-percha with a 0.5 Largo bur (Microdont Micro Usinagem de Precisão Ltda - SP - Brazil) for cementing a prefabricated 0.5 White Post fiberglass post (FGM Produtos Odontológicos - SC - Brazil) previously performed cleaning with alcohol and silanized with Prosil (FGM Produtos Odontológicos - SC - Brazil). After 60s and with a short air blast, excess silane is removed. The post was cemented with RelyX U 200 self-adhesive resin cement (3M Brasil - SP - Brazil) (Figure 1D). The excess fiberglass post was cut with a #4 spherical diamond bur (Microdont Micro Usinagem de Precisão - SP - Brazil) and the final restoration was performed with an Opallis composite resin (FGM Produtos Odontológicos - SC - Brazil) translucent in the palatal region (Figure 1E), opaque in the incisal region, and A3 and D3 in the buccal region by the stratification method (Figure 1F), with posterior finishing and polishing.

The same session included the selection of the prefabricated aesthetic veneers (Brilliant NG Componeer - Coltene) of incisal resin by size and translucency, whereas size L opaque bleach was chosen. Next, elements 11, 12, 21, and 22 were prepared with a light bevel on the buccal aspect with a 4138 bur (Microdont Micro Usinagem de Precisão - SP - Brazil) to reduce the convexity until fitting the veneers

(Figure 1G). The teeth and veneers were etched with 37% phosphoric acid (Condac FGM Produtos Odontológicos - SC – Brazil) (Figures 1H and 2A). Washing was performed with water blast for 20 s and, after removal, the tooth surface was briefly air dried. A conventional adhesive system (One Coat Bond SL – Coltene) of two steps with water base that does not change the physical conditions of the veneers was used. It was applied with a microbrush (Figure 2B) followed by light curing for 20 s, according to the manufacturer's instructions. Brilliant NG resin color scale was used (Brilliant NG Componeer - Coltene) for color selection of resin for cementation of facets. A thin layer of Opallis flow composite resin (high mechanical strength and low viscosity) (FGM Produtos Odontológicos - SC – Brazil) was placed on the buccal aspect of teeth and the veneer was pressed over this resin and later light cured for 40 s with Bluephase G2 (Ivoclar/ Vivadent - Liechtenstein) on all surfaces (Figure 2C). The excess resin was removed with a composite resin spatula. Each tooth was individually prepared and cemented to control the removal of excess cementing material. The palatal surfaces of teeth were filled with composite resin and the canine guide was set for tooth 13 in the incisal region by placing Opallis A3 composite resin (FGM Produtos Odontológicos - SC – Brazil) and later finishing and polishing (Figures 2D and Figure 3).

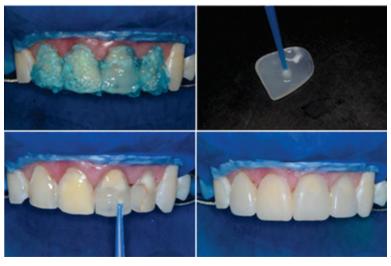
Figure 2: (A) 37% phosphoric acid etching with Condac 37 - Dentscare (FGM, Brazil); (B) Preparation of veneers with active application of Adper Single Bond II adhesive (3M, Brazil); (C) Active application of conventional adhesive of two steps (3M, Brazil) and light curing and (D) Thin layer of Opallis composite resin applied on the buccal aspect of teeth, followed by the positioning of veneers with mild pressure and light curing.

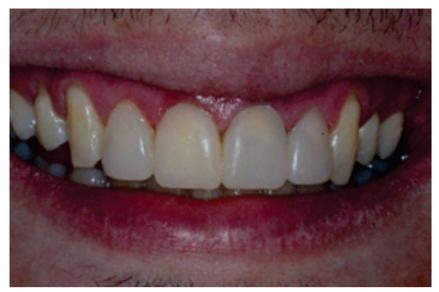
Figure 3: Final photograph.
