# DIRECT BONDED SPACE MAINTAINER: AN ALTERNATIVE IN CLINICAL PRACTICE AFTER UNILATERAL PREMATURE LOSS OF POSTERIOR PRIMARY TOOTH

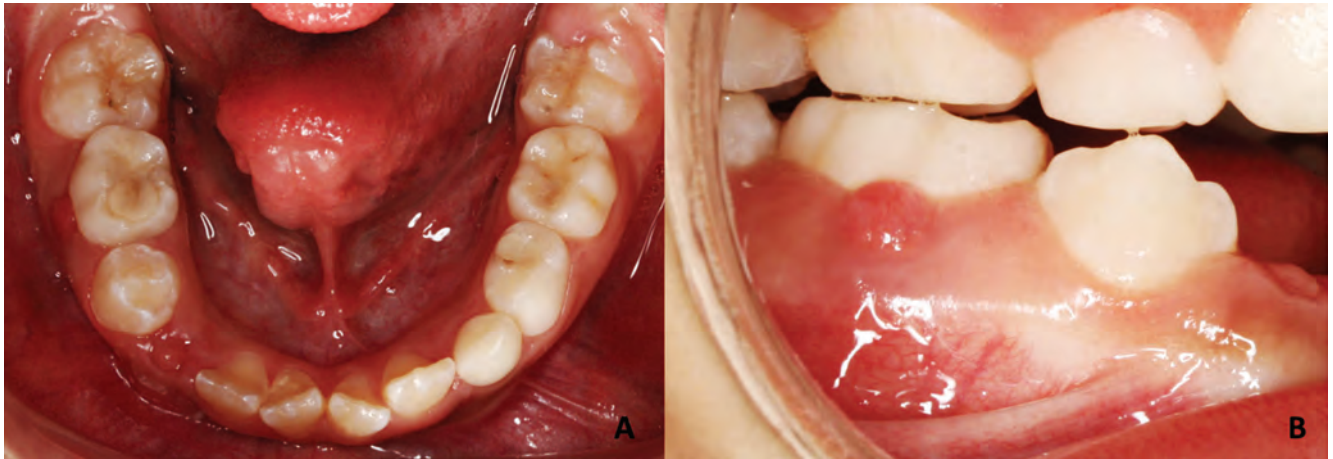
**Figure 1:** A - Composite resin restoration in primary mandibular left first molar, Glass ionomer restoration in primary mandibular right second molar. B - Dental fistula adjacent to the primary mandibular right second molar.

atresia, Angle class II molars, convex profile, 5 mm overjet and anterior open bite associated had mouth breathing. A Composite Resin restoration was found in primary mandibular left first molar, a Glass Ionomer restoration was found in the primary mandibular right second molar (Figure 1A) with adjacent fistula (Figure 1B) and absence of active carious lesions in the remaining teeth.

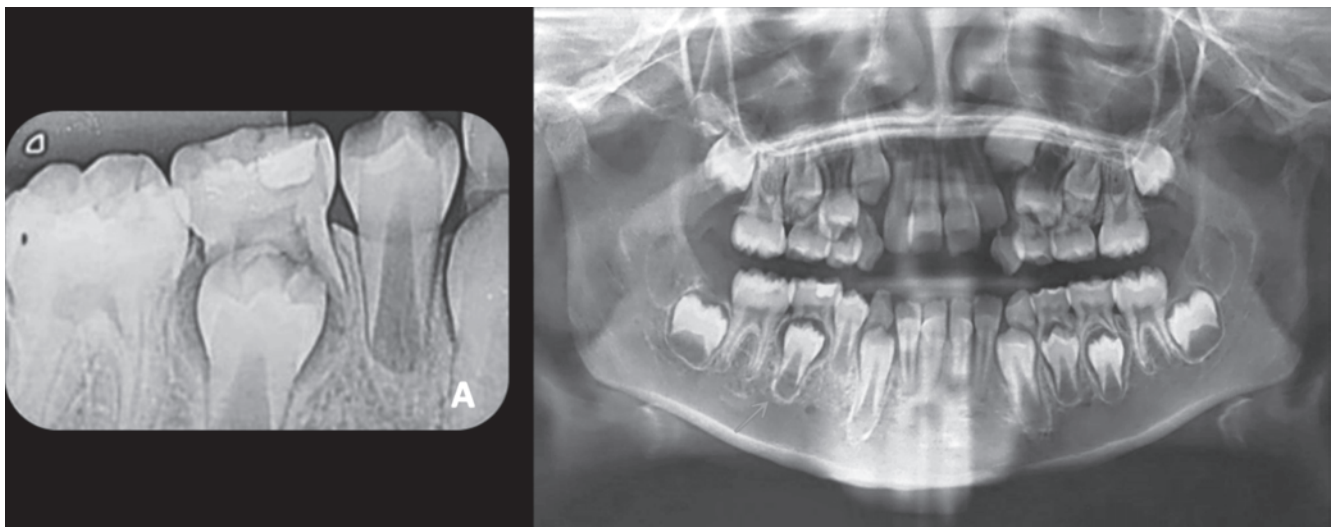
**Figure 2:** A - Periapical radiograph showing radiopaque restorative material in half of the dentin extension, with an underlying radiolucent area. B - Panoramic radiograph showing the root of the deciduous tooth had more than 2/3 rhizolyte and the permanent successor was in Nölla's stage 7.

At the radiographic examination of the primary mandibular right second molar, radiopaque restorative material was observed in half of the dentin extension, with an underlying radiolucent area (Figure 2A). In the panoramic radiography previously requested to aid in orthodontic planning, it was observed the root of the deciduous tooth had more than 2/3 rhizolyze and the permanent successor was in Nölla's stage 7 (Figure 2B). Due to the clinical and radiographic characteristics, the extraction of the primary mandibular right second molar and the placement of a direct bonded space maintainer were indicated. To avoid contamination of the conditioned enamel with blood, the bonding of the maintainer was performed before the extraction. The child was cooperative and all the clinical procedure was performed in a single appointment, without the need of previous molding to make the maintainer.

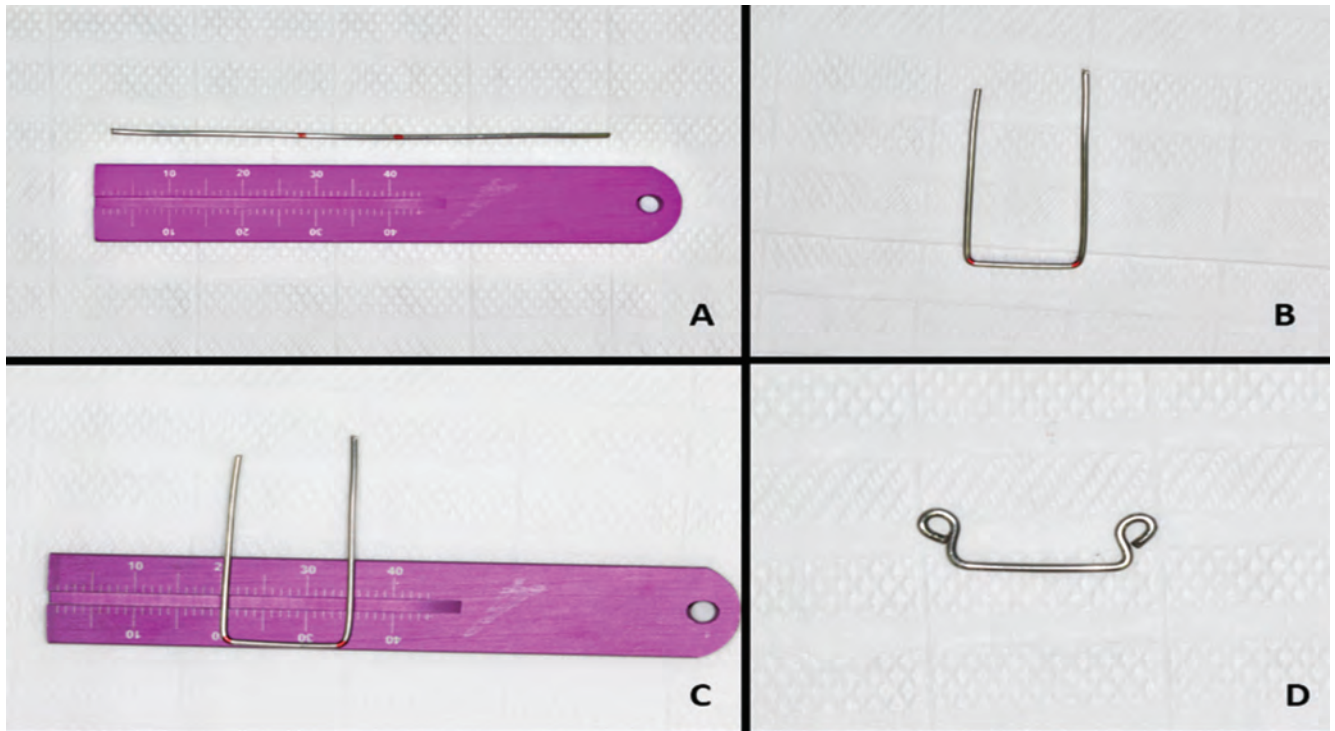
**Figure 3:** A - Transfer of space from the tooth to the wire. B- Straight folds over pen markings. C - Check of space measurement after wire fold. D - Maintainer completed after the looping realization at the ends that would be bonded on the teeth.

To begin, the referring space to the tooth which would be extracted was measured using a millimeter ruler (Maquira, Maringa, PR, Brazil). The measurement was transferred for the stainless steel wire 0,9mm, 036" (Morelli, Sorocaba, SP, Brazil) with aid a pen (Pilot, São Paulo, SP, Brazil) (Figure 3A). Straight folds (Figure 3BC) with loopings at its ends (Figure 3D) to increase retention of composite resin were made with the help of bird beak pliers #139 (Starlet, São Paulo, SP, Brazil). The supporting teeth used for the placement of the maintainer were the permanent mandibular right first molar and mandibular right first premolar.

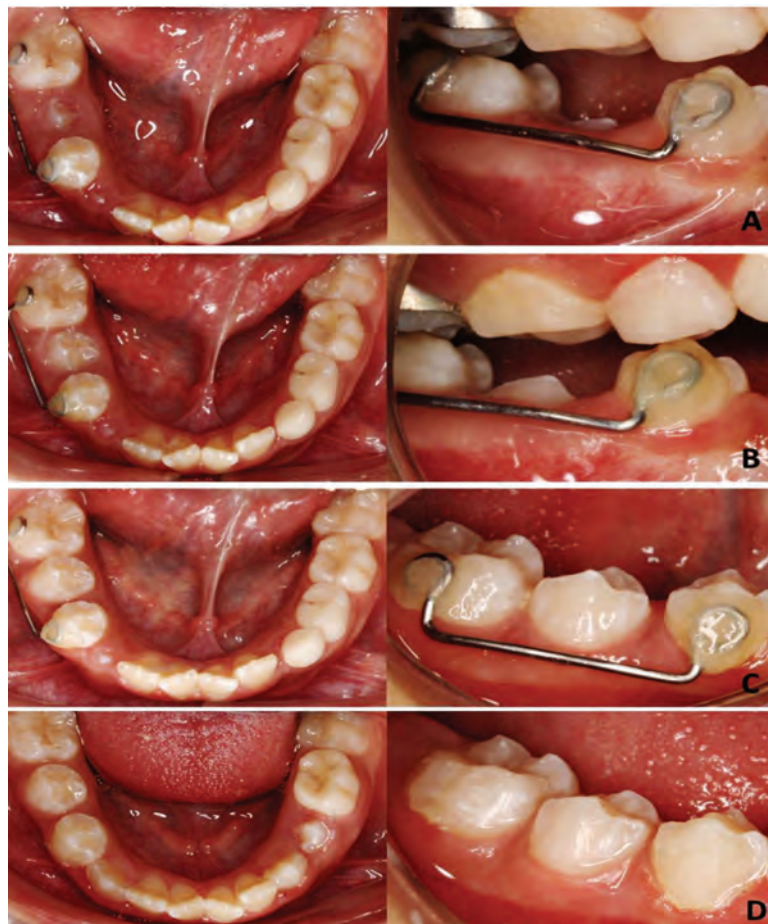
**Figure 4:** Clinical follow-up of the direct bonded space maintainer and successor eruption. A - Twenty-seven days later. B - Fifty-four days later. C - Eighty one days later. D - Clinical appearance after the removal of the device.

Every twenty-seven days, a follow-up was done to check the adherence of the maintainer or any situations that were out of the expected. Approximately three months after, in the appointments performed during interceptive orthodontic treatment, the eruption of the successor tooth was observed (Figure 4). In this way, the direct bonded space maintainer was removed and the remaining composite resin was removed with multilayer drills in low-speed. The occlusion was checked and the enamel of the supporting teeth was polished.
